Notice of Locomotive Change for the “SL Fuyu-no-Shitsugen Train”

【Condition of the piston ring on the steam locomotive (C11-171)】

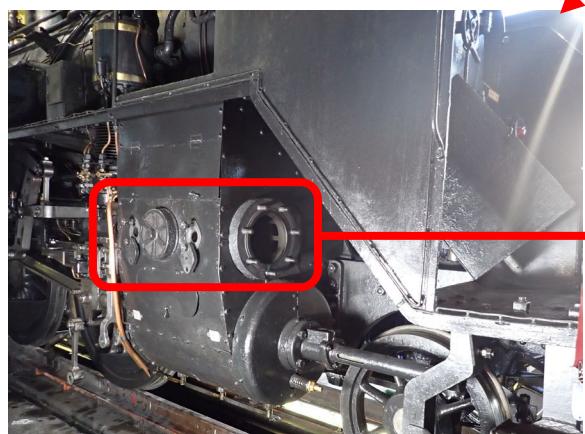
Exterior of the steam chamber
(after removal of the piston)

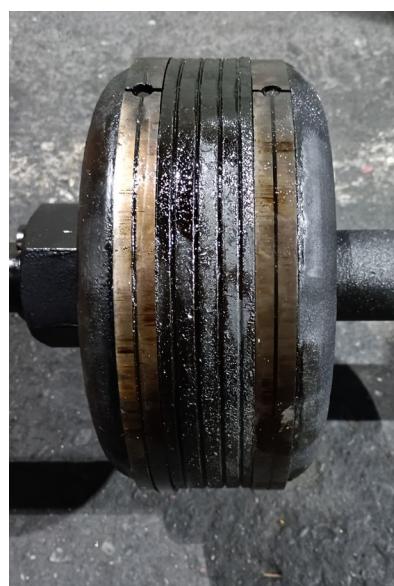
For reference: Normal piston ring

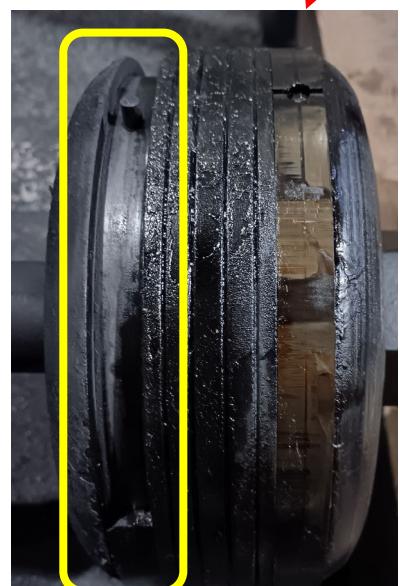
Regarding the steam locomotive (C11-171) currently used for the “SL Fuyu-no-Shitsugen Train”, three incidents occurred during operation on January 31 in which the locomotive was temporarily unable to start when departing from stations. On February 1, as a precaution in case the steam locomotive did not generate sufficient power, the service was operated with a diesel locomotive coupled in addition to the steam locomotive. Following a detailed inspection conducted on February 2, it was confirmed that a piston component (piston ring) in the steam chamber—responsible for converting steam into motive power—had fractured. This damage caused steam leakage, resulting in insufficient power for starting.

Damaged piston ring
(area outlined in yellow)

While we are continuing to investigate the detailed cause, repairs are expected to require a significant amount of time. Therefore, the locomotive for the “SL Fuyu-no-Shitsugen Train” will be changed to a diesel locomotive.
